Mangere WWTP

March 2015

Mangere Wastewater Treatment Plant

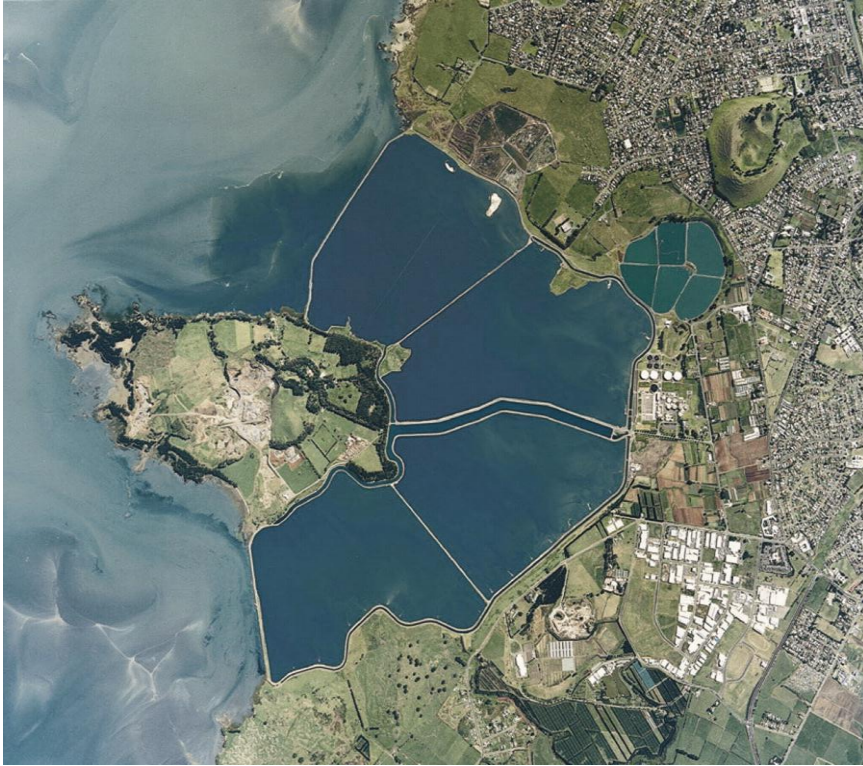
Pre - 2002

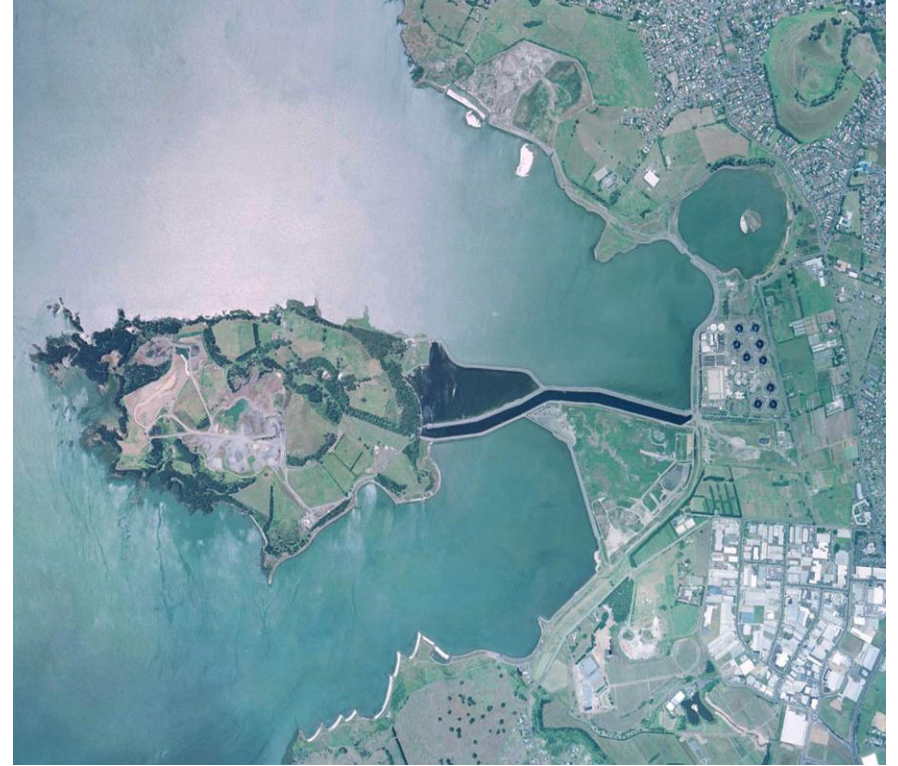
Post - 2002

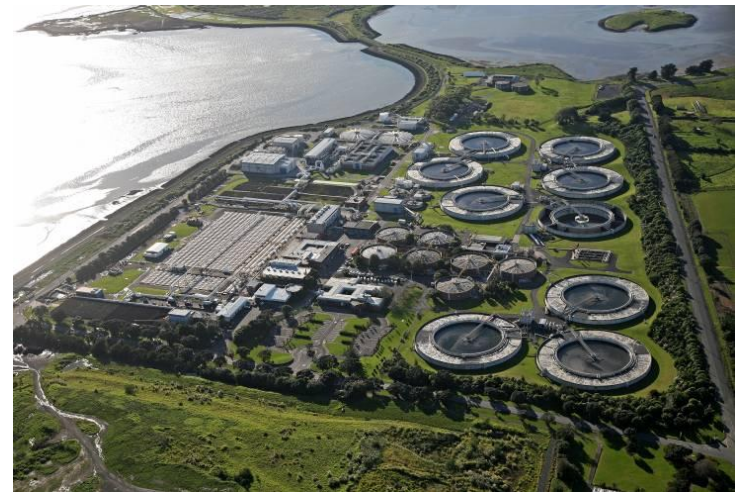
Treatment Summary

- All incoming wastewater receives preliminary treatment, UV disinfection & at least one other process
- 97.8% of time flows receive total treatment
- Primary treatment removes 60% solids & 40% BOD
- Secondary treatment removes nutrients and remaining solids & BOD
- Filtration removes particulates
- UV disinfects for public health
